Vol. 3 Issue 3

Anti-siphon device

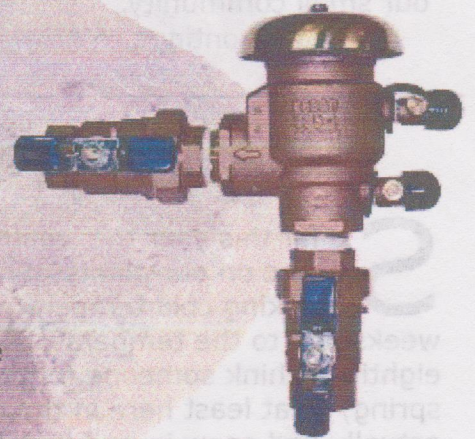
The better anti-siphon device to install would be a Pressure Vacuum Breaker or PVB. These are typically brass units that need to be installed a minimum of 12" above grade. The "pressure" part of the anti-siphon device is achieved from internal springs that force the valves closed when no water is present. This type of unit is generally required for a licensed contractor to work on your irrigation and the good part of this unit is only one needs to be installed per irrigation system. Once you have a proper anti-siphon device installed we can confidently move on to installing a fertilizer unit on our irrigation system to allow us to inject fertilizer into the water that waters our plants.
